**INVESTIGATION, RESEARCH AND TESTING****Since 1970****Vehicle Collision Reconstruction and
Biomechanical Analysis***Robert Marberger v. Jeremy R. Nivens and DZYK Transportation Services, LLC*

In the United States District Court for the
District of South Carolina, Columbia Division
C.A. No. 3:22-cv-02375-MGL

Date of Incident: September 9, 2021

S-E-A Matter No. 11.148372

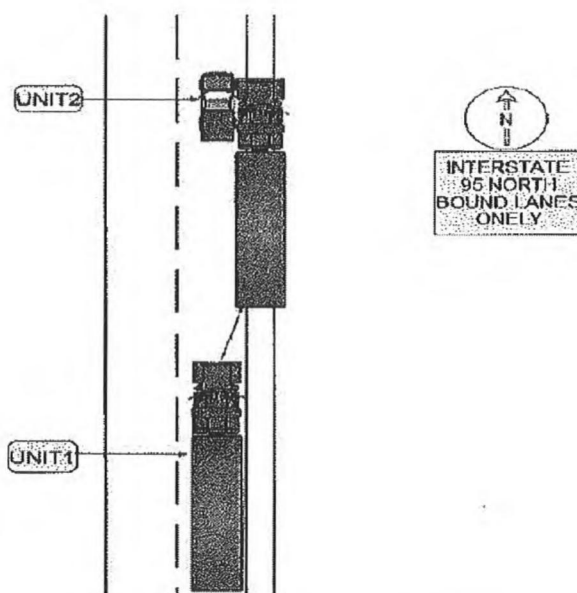
"Units 1 [Peterbilt] and 2 [Chevrolet] were traveling north on Interstate 95. Unit 1 [Peterbilt], who was driving too fast for conditions, sideswiped Unit 2 [Chevrolet]." The Crash Report diagram depicts the Chevrolet in the rightmost lane of I-95, whereupon the Peterbilt moved to the right shoulder and sideswiped the Chevrolet (Figure 1).

Figure 1: Crash Report 21273290 diagram.

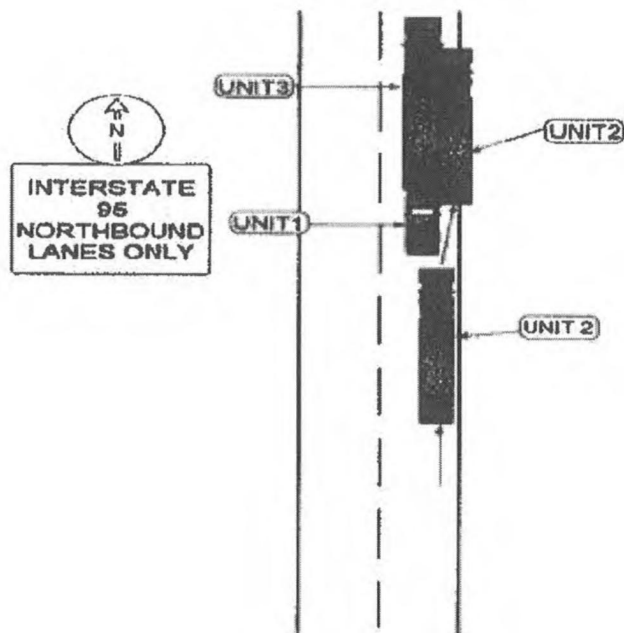
"Unit 1 [Chevrolet], who was driving too fast for conditions, struck the rear of Unit 3 [International]. Unit 2 [Peterbilt], who was also driving too fast for conditions, struck the rear of Unit 1 [Chevrolet] before striking the side of Unit 3's [International's] trailer." The Crash Report diagram depicts all 3 vehicles in the rightmost lane of I-95, with the Chevrolet crashing into the rear of the International, followed by the Peterbilt moving to the right shoulder again, and making contact to the other vehicles (Figure 2).

Figure 2: Crash Report 21273291 diagram.

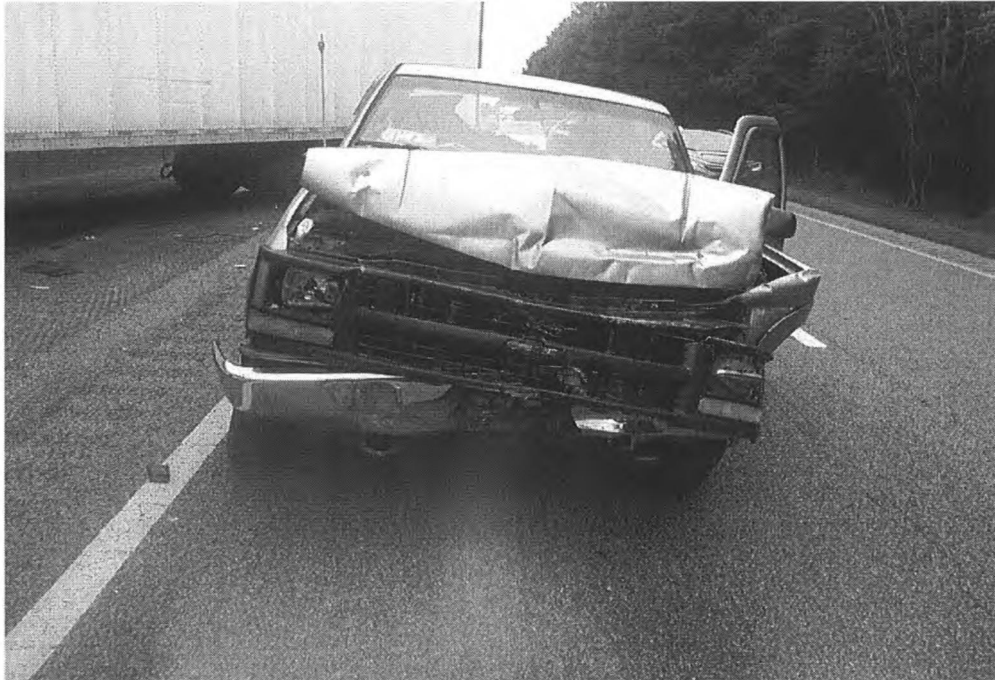
Figure 5: Chevrolet, front view at the Site (provided photograph).

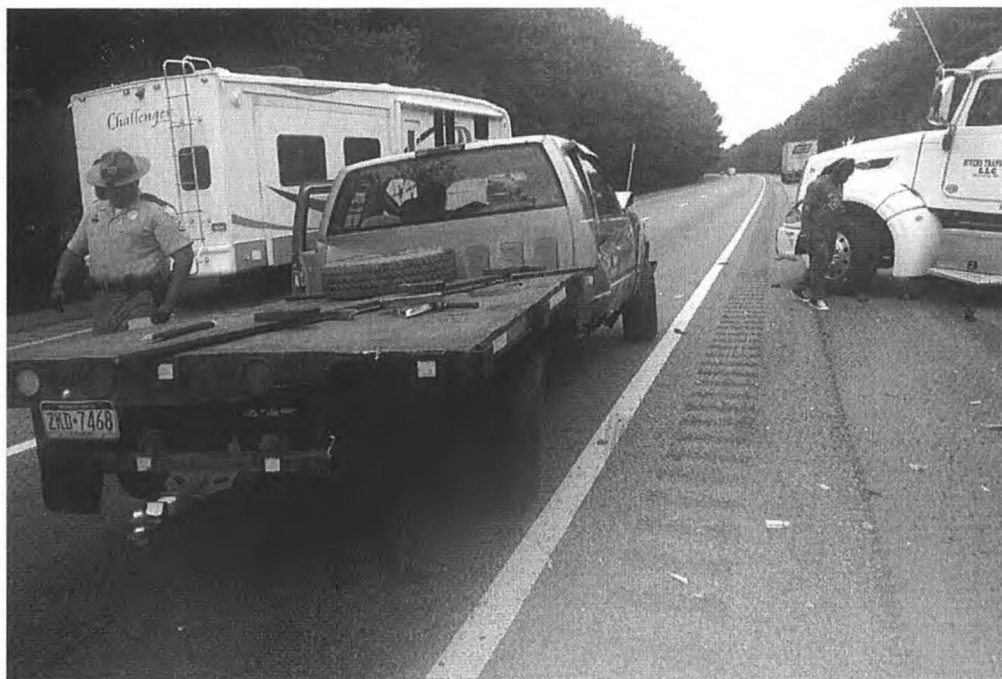
Figure 6: Chevrolet, right-rear corner view at the Site (provided photograph).

A review and analysis of the provided and available data was performed to attempt to reconstruct the evidence in this matter. As seen in Figure 6, the Chevrolet came to rest in the rightmost lane of I-95 N, near the right edge. The International (Cowan) vehicle is stopped ahead on the right shoulder, estimated at approximately 200 to 300 feet ahead. The Peterbilt is angled counterclockwise to the travel direction and is on the right shoulder, split between pavement and grass shoulder (see Figure 14). Excerpted from the provided SCDPS video, **Figure 15** depicts the trailer in-tow by the Peterbilt at final rest, along with tire marks of the trailer as it departed the roadway.

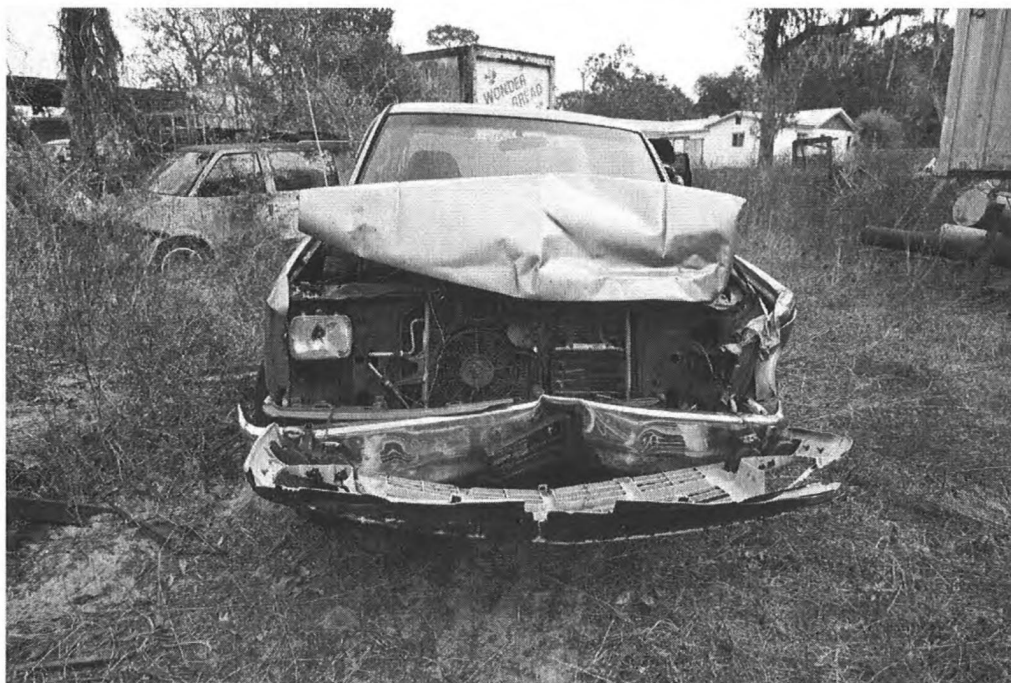
The front structures of the Chevrolet are notably crushed (longitudinally rearward), with a vertical narrow object impression to the front bumper structure at or near its midline. The hood is folded upward, seemingly hinged at the crush bead within its frame. The left side fender and structures are more displaced than the right, consistent with an offset/angular hit (**Figure 9** and **Figure 10**).

Figure 7: Chevrolet, front view (S-E-A inspection).

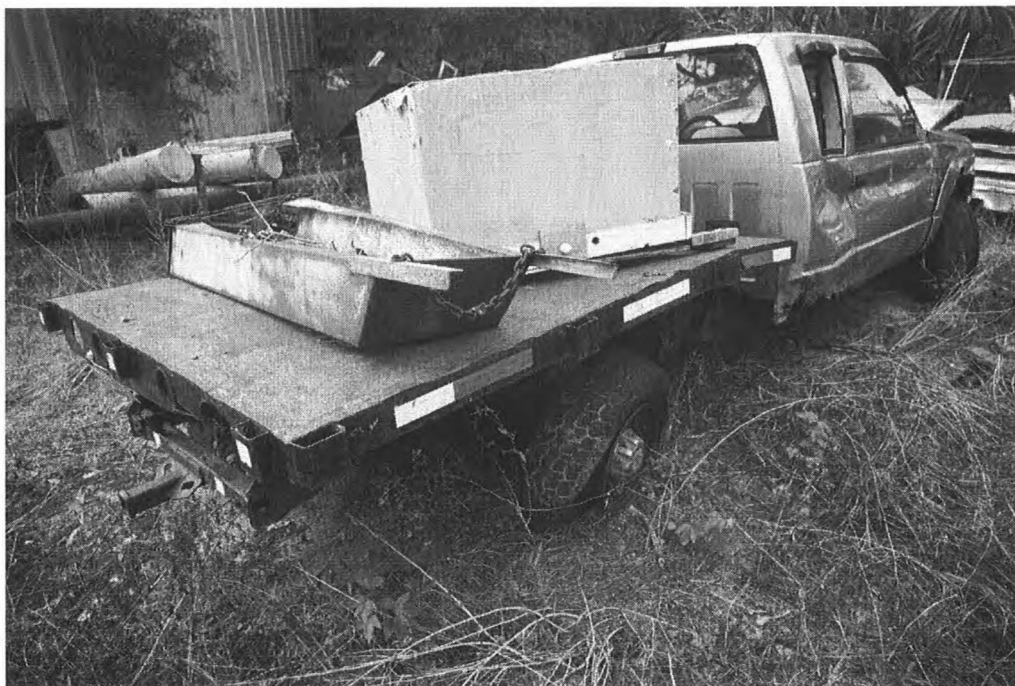
The Chevrolet was inspected by S-E-A on December 18, 2024, in Hudson, Florida. Initial investigation of the Chevrolet found a few noticeable differences in the vehicle since the time of the MVC, but overall, much of the vehicle at least appeared similar to the post-MVC photographs. At the front of the vehicle, the grill was no longer in place (**Figure 7**), while at the rear, the hitch ball and mount had been removed, as well as some of the rear lighting (**Figure 8**).

Figure 8: Chevrolet, right-rear corner view (S-E-A inspection).

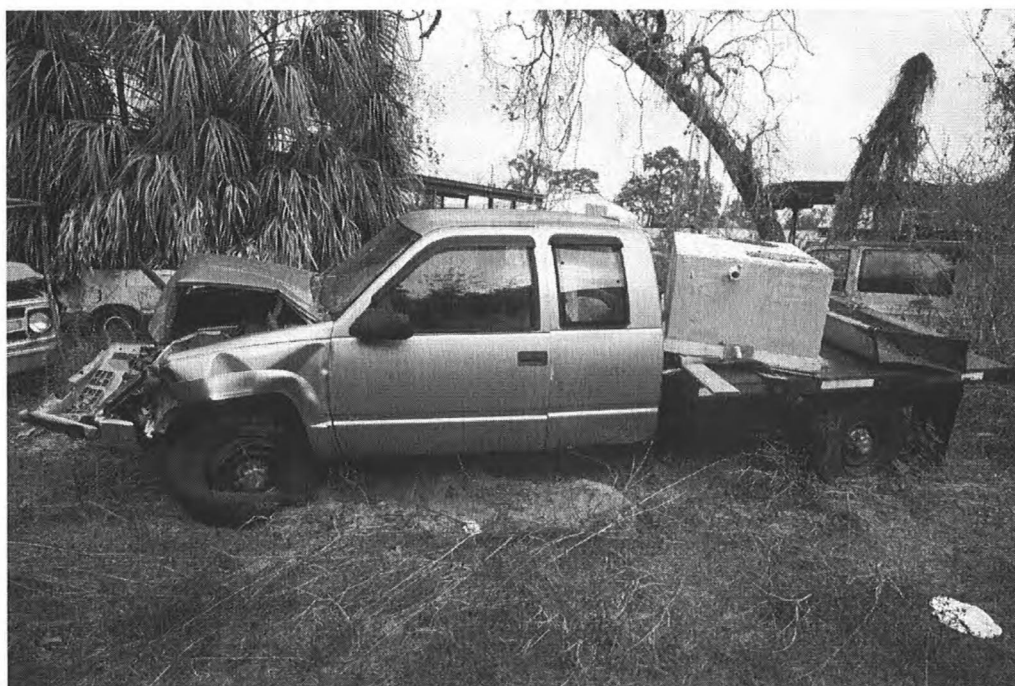
Figure 9: Chevrolet, left side view (S-E-A inspection).

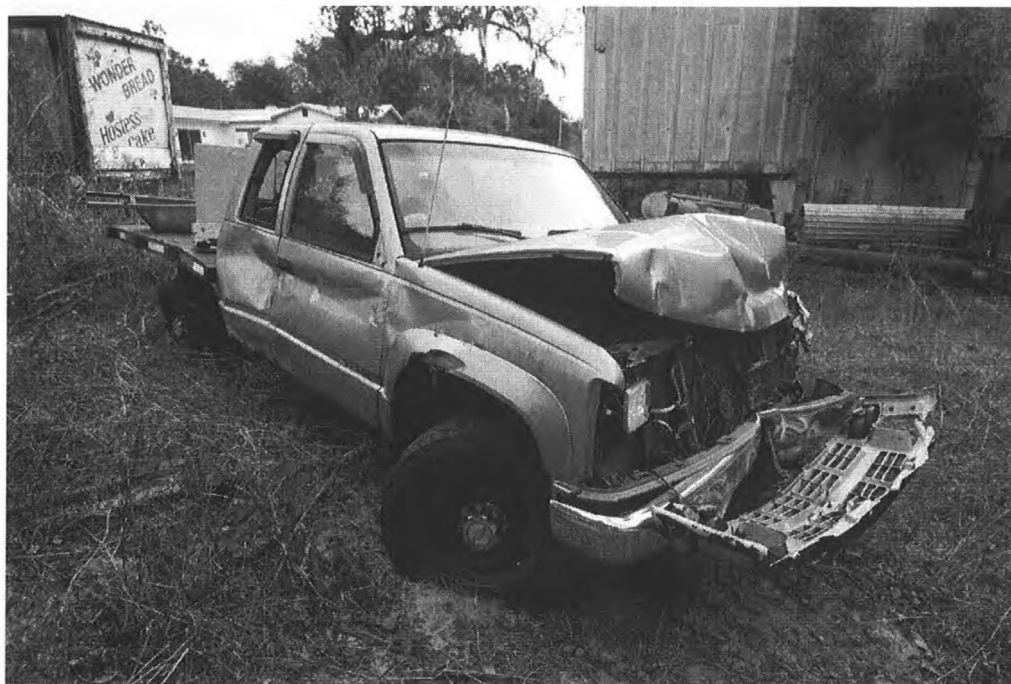
Figure 10: Chevrolet, right-front view (S-E-A inspection).

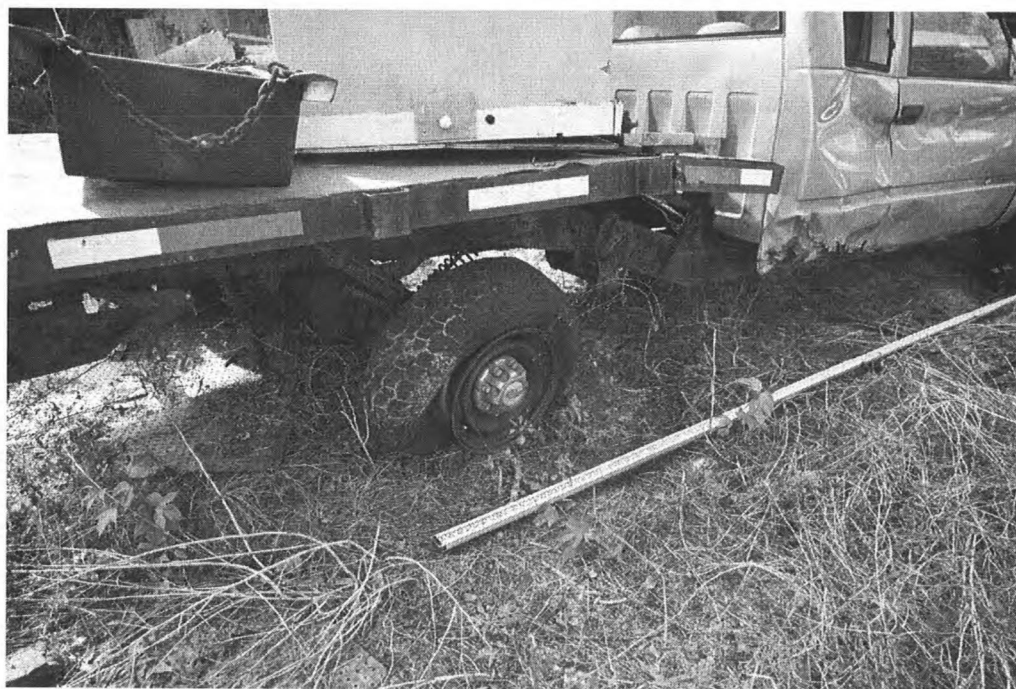
Separate from the frontal damage, the flat bed remained secure to the frame of the Chevrolet and maintains its general structural profile, albeit somewhat out-of-plane (**Figure 11**). The right-rear tire is flat, but the wheel is structurally intact without evidence of significant loading. The

forward area of the right leaf spring is bent, but the overall structure appears intact. Additionally, a generally horizontal and vertically narrow crease within the right-side door panels is evident (**Figure 12**). There is lateral displacement of the exterior right-side door panels, but no evidence of significant longitudinal gouging and scraping.

Figure 11: Right rear wheel and suspension of Chevrolet (S-E-A inspection).

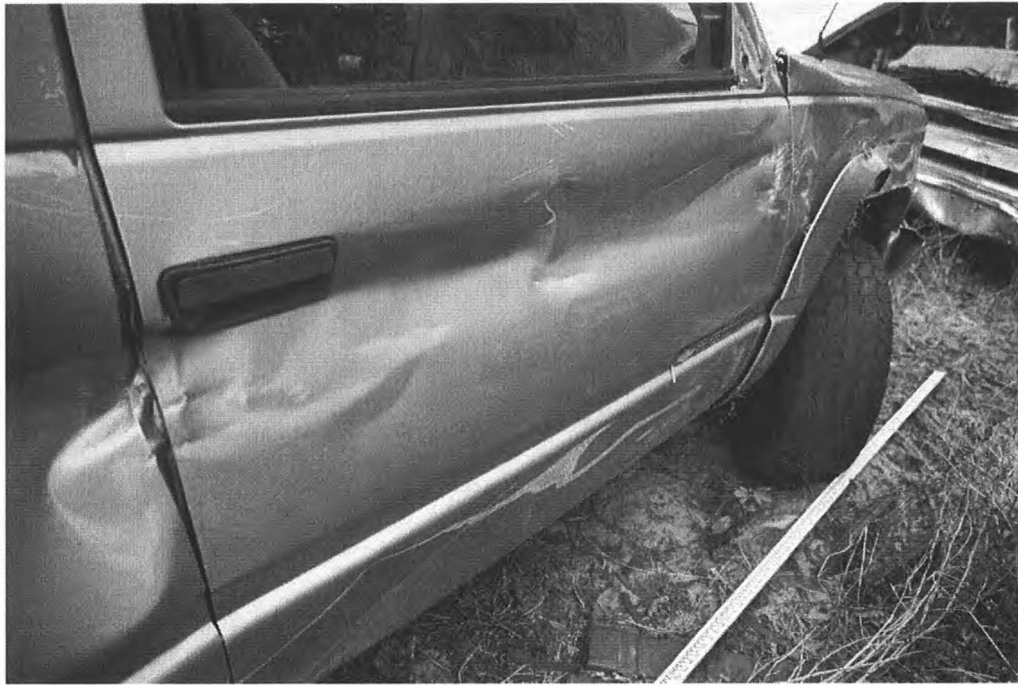
Figure 12: Right door of Chevrolet (S-E-A inspection).

In addition to the frontal impact, the Chevrolet exhibited contact along its right side. The crush along the right-side doors was vertically narrow and did not significantly involve the primary structures such as the side sill or A- and C-pillars. Utilizing this crush profile, the BEV of the Chevrolet related to the side crush of the door panels was in the range of only 5 to 6 mph. In addition, side swiping of the flat bed, as well as deflection of the leaf spring occurred but does not seemingly account for the input of sufficient energy to account for the frontal crash of the Chevrolet to the International. For the reasonably quantifiable damage, **the energy associated with the frontal crush of the Chevrolet to the International significantly exceeded that evident within the sideswipe engagement(s) between the Peterbilt and the Chevrolet.**

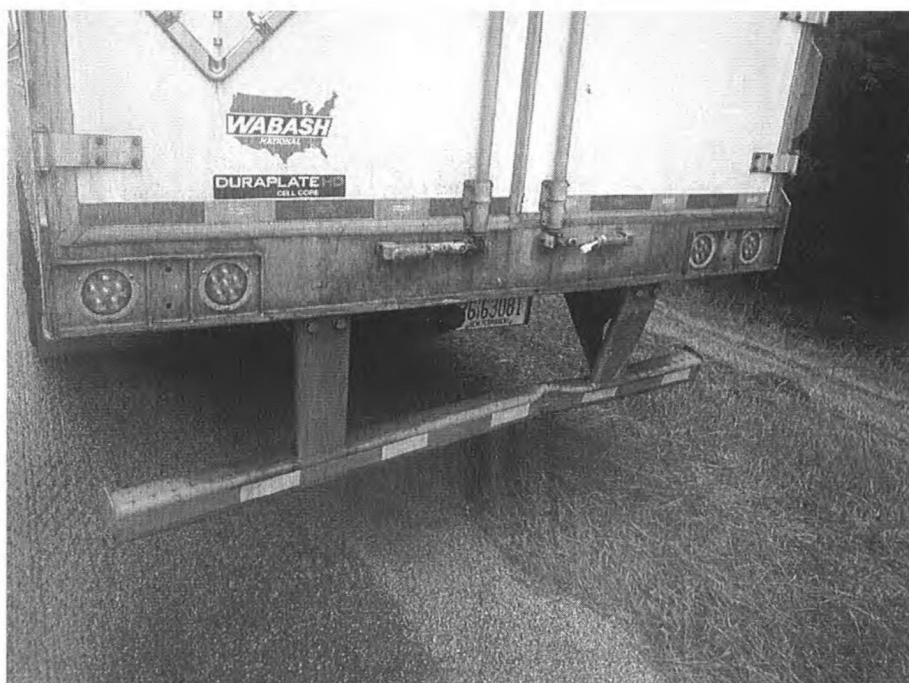
The subject International bears VIN 3HSDZTZRXLN102113, indicating that it is a 2020 International LT625, with an L6, 12.4L diesel engine. As depicted in the Crash Report, the International was towing a semi-trailer at the time of the MVC. Post-MVC photographs were provided and depict MVC damage to the International (**Figure 13**). These photographs depict contact damage at the rear of the trailer at the ICC bar. ECM data from the International was not provided/available for review and analysis.

Figure 13: International semi-trailer, rear view at the Site (provided photograph).

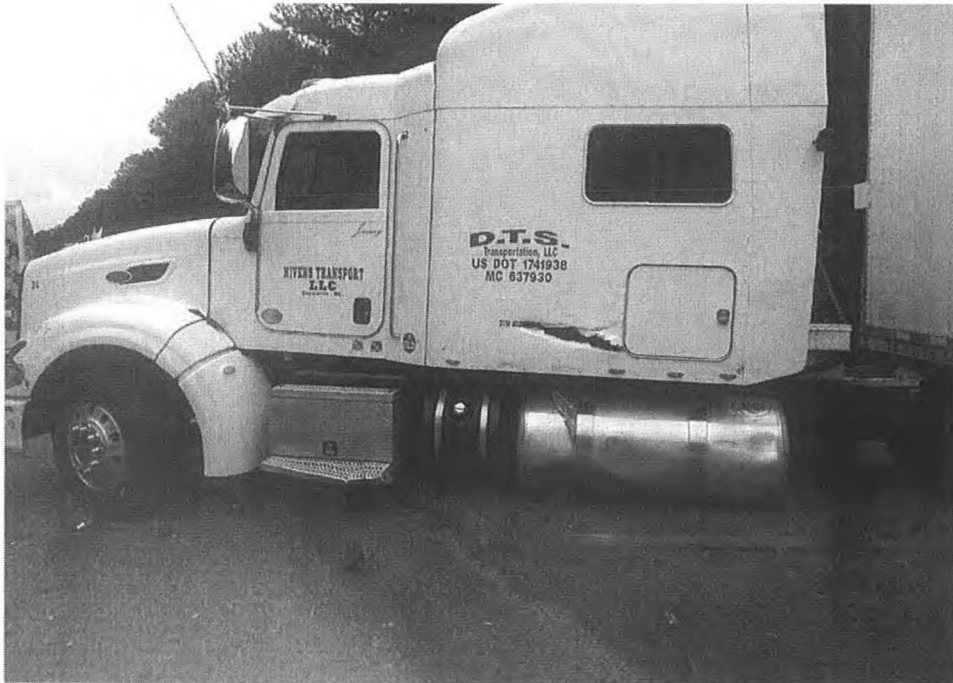
The subject Peterbilt bears VIN 1XPHDP9XXDD194694, indicating that it is a 2013 Peterbilt 386, with an L6, 12.9L Paccar engine. As depicted in the Crash Report, the Peterbilt was towing a semi-trailer at the time of the MVC. Post-MVC photographs were provided and depict MVC damage to the Peterbilt (**Figure 14**). These photographs depict slight contact damage to the fiberglass hood and fender structure adjacent to the left headlight, deflection of the lower driver entry step, scuffing and denting of the saddle tank, as well as a singular gouge to the sleeper berth body shell. ECM data from the Peterbilt was not provided and/or was not available for review and analysis.

Figure 14: Peterbilt, left side view at the Site (provided photograph).

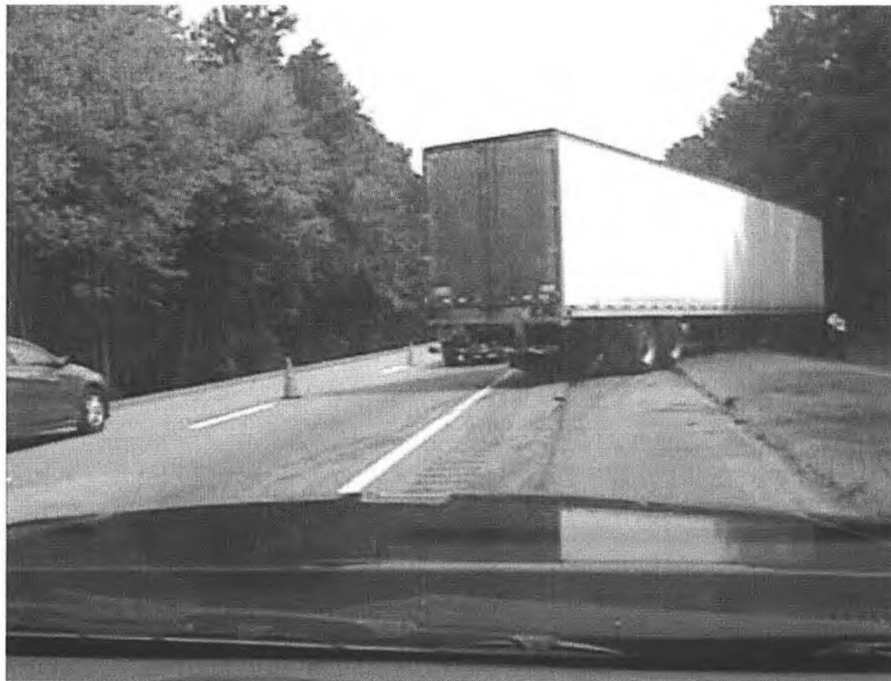
Figure 15: Trailer in-tow by Peterbilt, post-MVC (provided photograph).
